Manhole Inspection Summary

Manhole # S47W1_008MH

Insp Date: **6/2/09 12:05 PM**

Location Address: **Chesapeake Ave.**

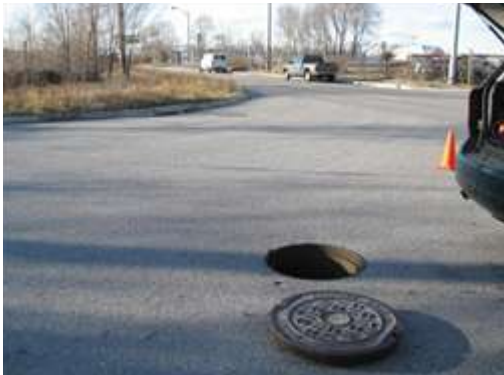
Location View

1225 Chesapeake Ave.

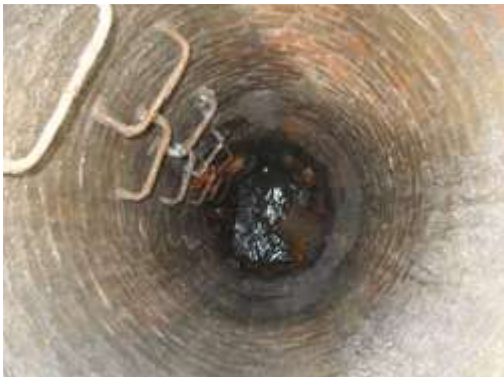
Steps

Count: **14** Missing: **0** ☒ **Corroded**

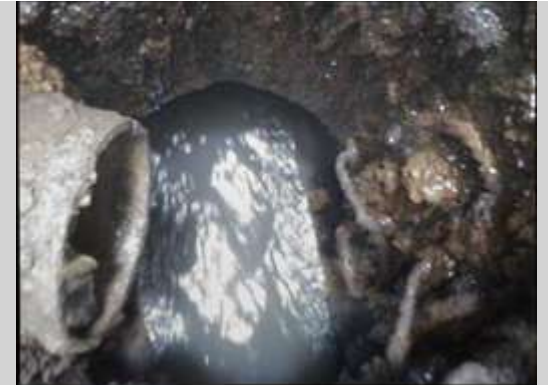
12 O'Clock Outflow

42 in. Circular Gravity Sewer
Pipe Out @ 12 O'Clock

Pipe Height: **43.2** (in.) Rod and Bar (Angled)
Pipe Material: **Clay** ☐ Pipe Lined
Invert Depth: **21.70** (ft.) Flow Characteristics: **Fast**
Deposits: ☒ None ☐ Mud ☐ Sludge ☐ Debris ☐ Grease
Silt Depth: (in.) Deposits Extent:
Infiltration: **None** Pipe Seal Cond: **Sound**

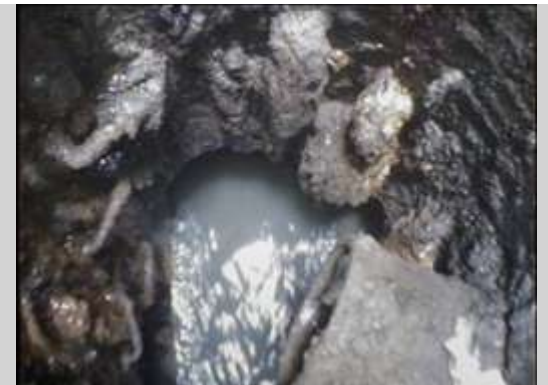
6 O'Clock Inflow

42 in. Circular Gravity Sewer
Pipe In @ 6 O'Clock

Pipe Height: **43.2** (in.) Rod and Bar (Angled)
Pipe Material: **Clay** ☐ Pipe Lined
Invert Depth: **21.80** (ft.) Flow Characteristics: **Fast**
Deposits: ☒ None ☐ Mud ☐ Sludge ☐ Debris ☐ Grease
Silt Depth: (in.) Deposits Extent:
Infiltration: **None** Pipe Seal Cond: **Sound**

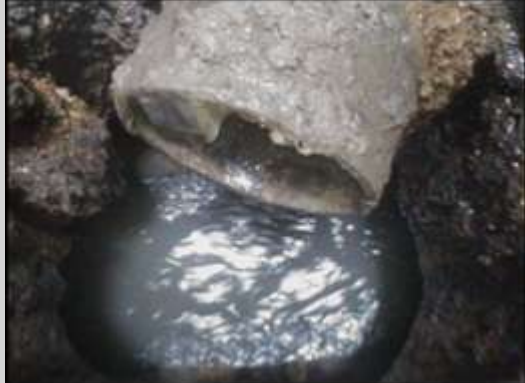
10 O'Clock Inflow

8 in. Circular Gravity Sewer

Pipe In @ 10 O'Clock

Pipe Height: **13.2** (in.) Rod and Bar (Angled)

Invert Depth: **16.22** (ft.) Flow Characteristics: **None**

Infiltration: **None** Pipe Seal Cond: **Sound**
